# Manhole Inspection Summary

Manhole # S31II\_016MH

**Location** Address: **1501 MOSHER ST**

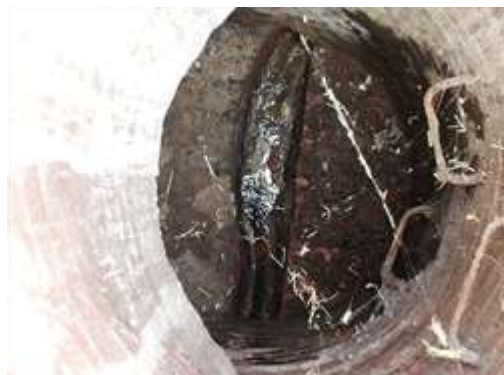
Top View

Corroded and missing steps. Evidence of surcharge - Bench debris. Channel debris.

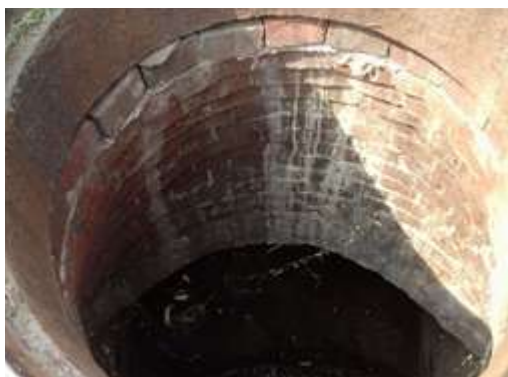
Defect

Frame leaks. Adjustment deterioration and infiltration. Barrel infiltration - other side.

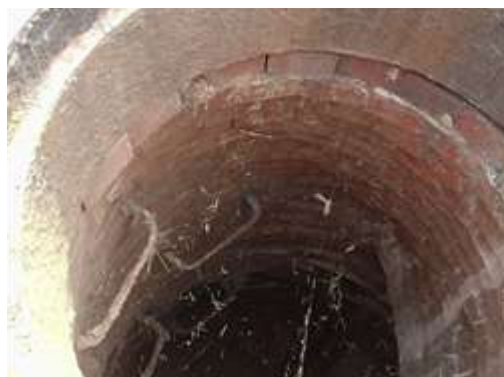
Defect

Frame leaks. Adjustment deterioration and infiltration. Barrel infiltration.
